RESERVE FUND STUDY UPDATE WITH SITE VISIT OTTAWA CARLETON CONDOMINIUM CORPORATION No. 553, OTTAWA, ONTARIO

Based on our visual examination of the property, it is our opinion that Ottawa-Carleton Condominium Corporation No. 553 is in generally satisfactory condition. A number of common elements will, however, require repairs or replacement over the 30-year horizon of this reserve fund study.

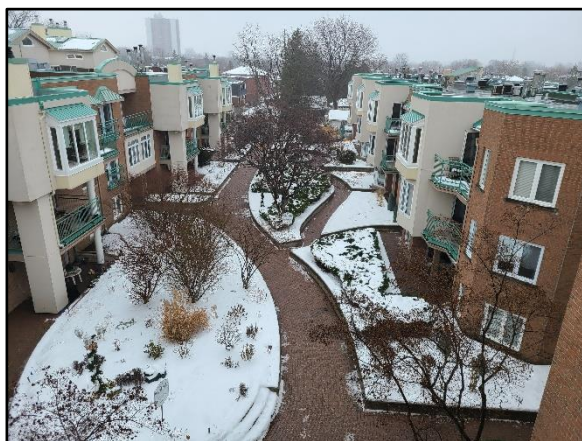
The waterproofing under the landscaping was installed as part of the original construction; as such is 28 years old. While no active leaks were noted during our inspection, Keller noted multiple areas of previous crack injection repairs and evidence of previous water infiltration through the podium soffit. While no active leaks were observed, based on the age of the membrane as well as the evidence of previous water infiltration, we expect the membrane is in fair condition.

Figure 5.1.2.a View of Podium Deck

- .E **\$11,300** has been budgeted in fiscal years **2020/21, 2023/24, and 2026/27** to complete the work as detailed within the Cleland Jardin Podium Condition Assessment Report
- .F **\$1,288,794** has been budgeted in fiscal year **2030/31** to complete the work as detailed within the Cleland Jardin Podium Condition Assessment Report

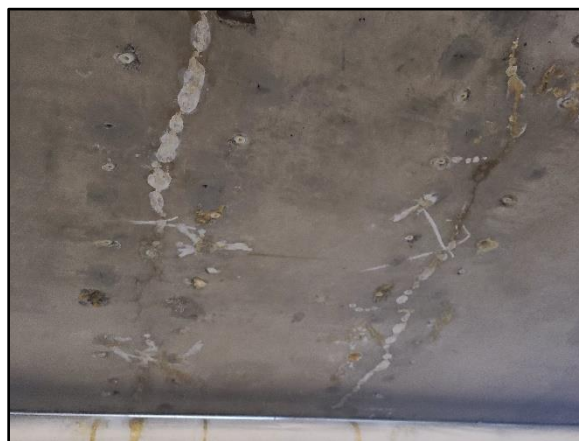
According to the Podium Condition Assessment dated June 22, 2021 by Cleland Jardine Engineering Ltd, the podium waterproofing requires additional maintenance to extend it's service life. The condition assessment recommends the following funding plan:

Figure 5.1.2.b Showing previous water infiltration and crack injection

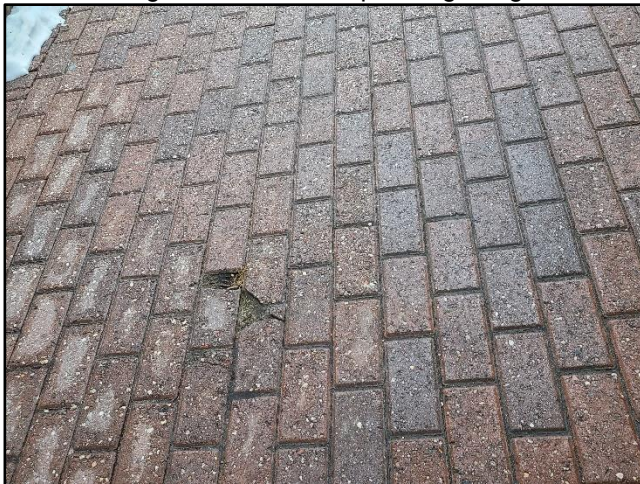
The on-grade pavers installed as part of the original construction; as such are 28 years old. The pavers are in fair-to-satisfactory as localized areas of spalled units as well large areas of settlement were observed. Periodic replacement and resetting of localized areas should be performed as required.

Figure 5.1.4.a Localized damaged units

- .A In order to ensure funds are available to perform isolated resetting and replacement when required, an allowance of **\$5,000** has been made in fiscal year **2022/23** and **every 10 years thereafter excluding years of full replacement**
- .B Replacement of the on-grade paver walkways and patios is estimated to cost **\$50,000** and this work has been budgeted in fiscal year **2042/43**
- .C Costs for replacement of the pavers have been included with the replacement of the podium membrane
- .D Minor resetting of the pavers should be performed as required using funds from the operating budget

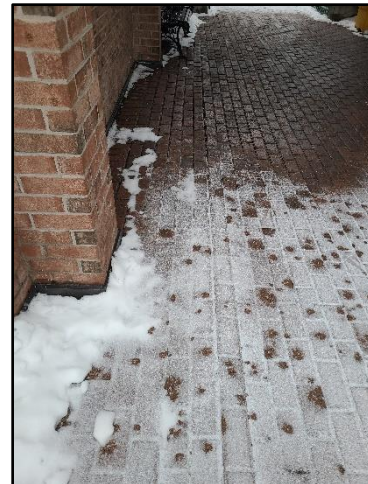
Figure 5.1.4.b Localized settlement

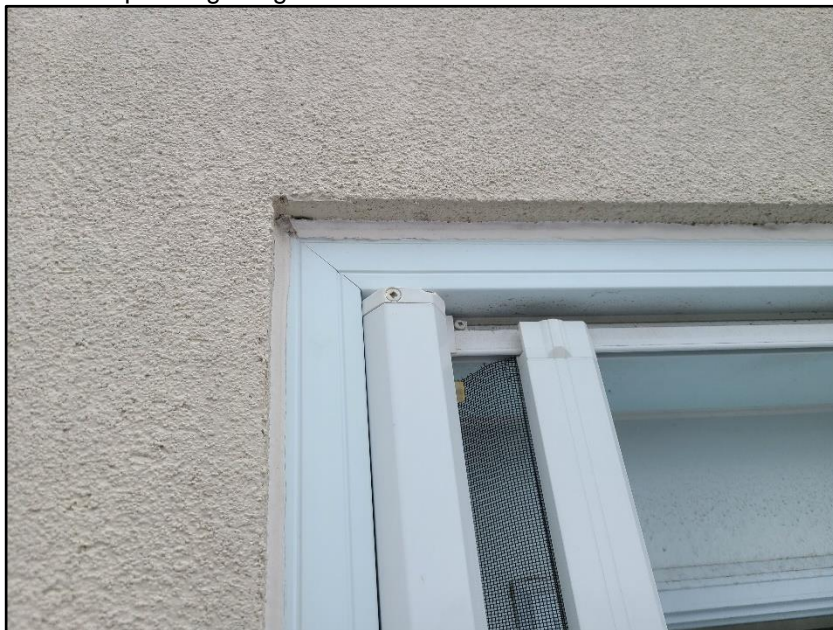
Figure 5.1.11.a Typical missing head flashing at balcony doors or windows.

- .A Recoating of the EIFS and modification of the flashing is estimated to cost **\$155,000** and this work has been budgeted in fiscal year **2028/29 and every 15 years thereafter until time of replacement**
- .B Replacement of the EIFS is estimated to cost **\$675,000** and this work has been budgeted **beyond the 30-year planning period** of this study
- .C Minor repairs of the EIFS should be performed, as required, using funds from the operating budget

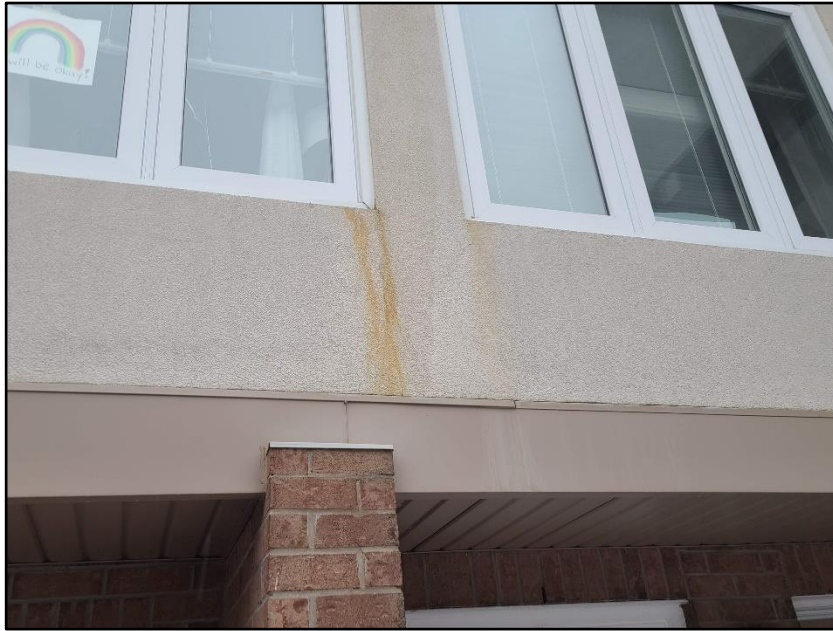
Figure 5.1.11.a Typical staining noted at windows. Note poor sill flashing detail

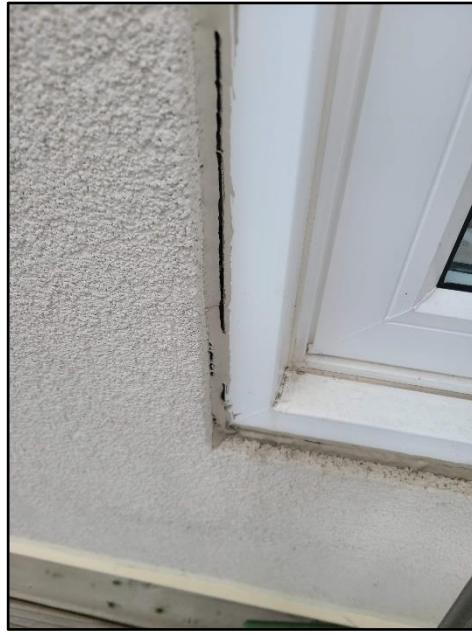
Figure 5.1.12.a Typical split caulking

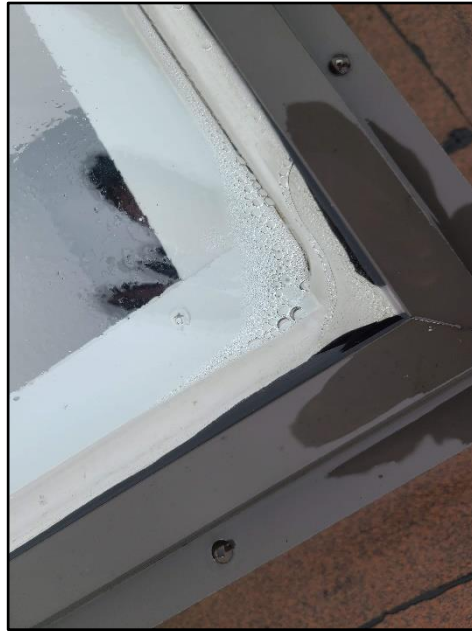
Figure 5.1.13.a Failed skylight seal

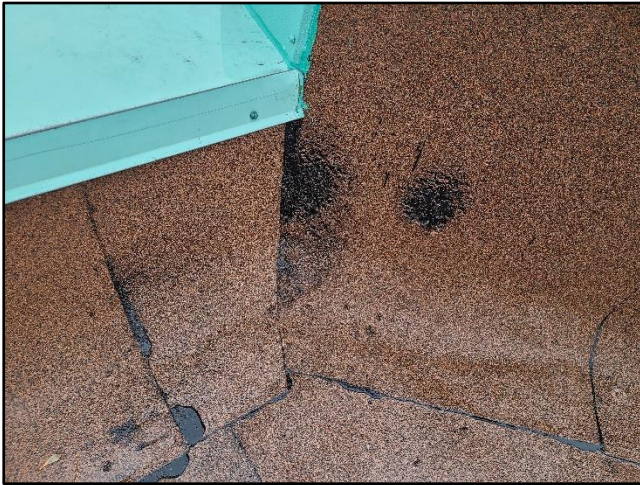
Figure 5.1.15.a Over torched membrane

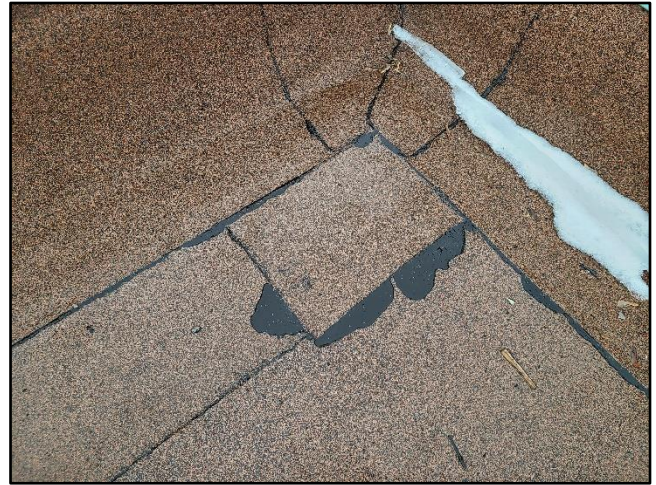
Figure 5.1.15.b Over torched membrane

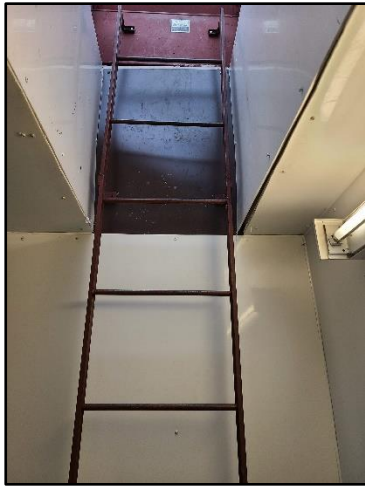
Figure 5.1.15.c Roof access ladder. Hatch pointed in wrong direction

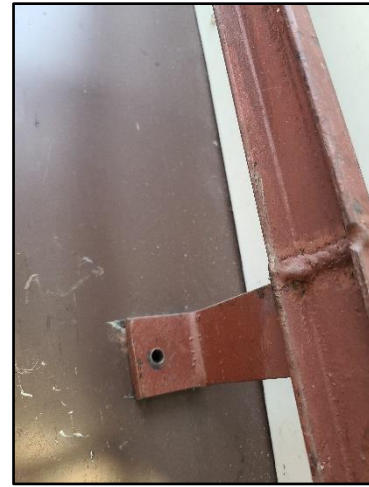
Figure 5.1.15.d Access ladder missing anchorage points

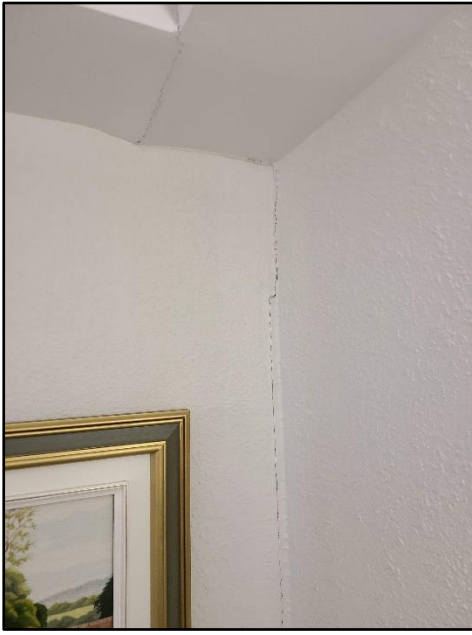
Figure 5.1.16.a Typical cracking

- .A Repainting of the walls is estimated to cost **\$60,000** and this work has been budgeted over a **2-year period beginning** in fiscal year **2029/30** and **every 10 years thereafter**
- .B Minor patch repairs should be performed, as required, using funds from the operating budget

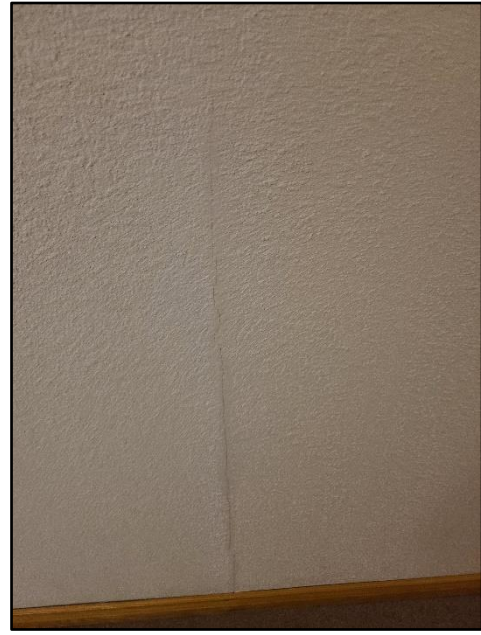
Figure 5.1.16.b Typical cracking

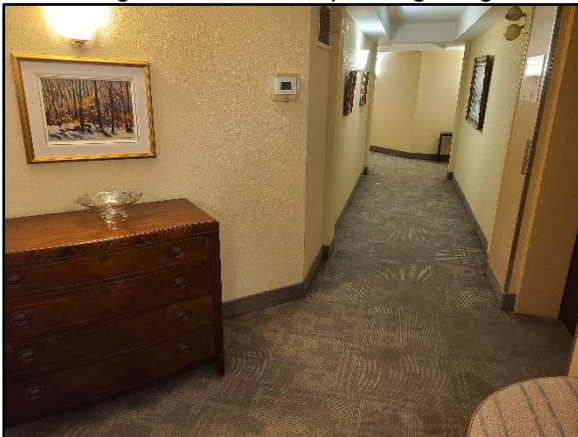
Figure 5.1.16.c Varying condition of carpet in each building

- .C In order to ensure funds are available to perform replacements when required, an allowance of **\$10,000** has been made in fiscal year **2024/25** and **every 5 years thereafter**
- .D Minor repairs of the carpet should be performed, as required, using funds from the operating budget

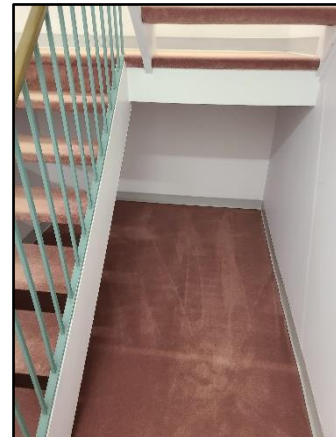
Figure 5.1.16.b Varying condition of carpet in each building

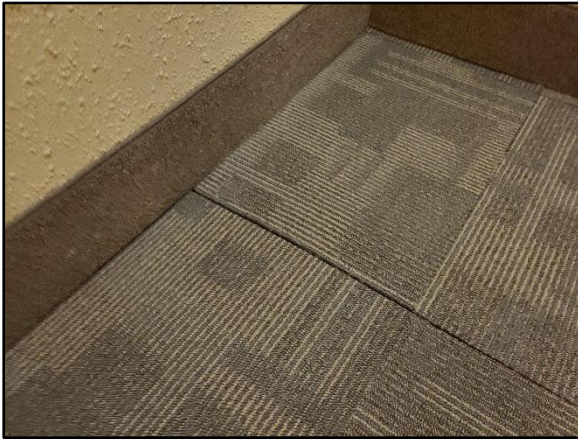
Figure 5.1.16.e Lifting tile in Building C

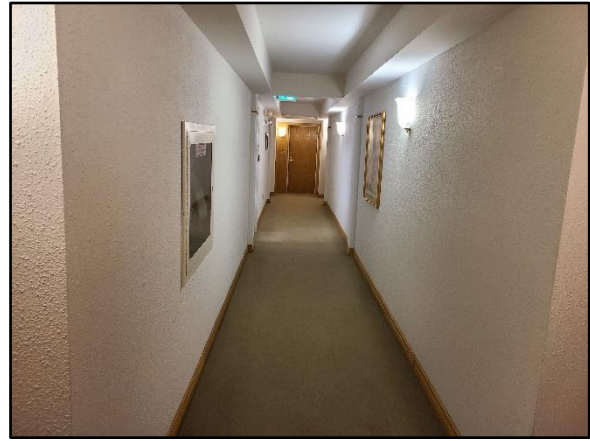
Figure 5.1.16.f Varying condition of carpet in each building

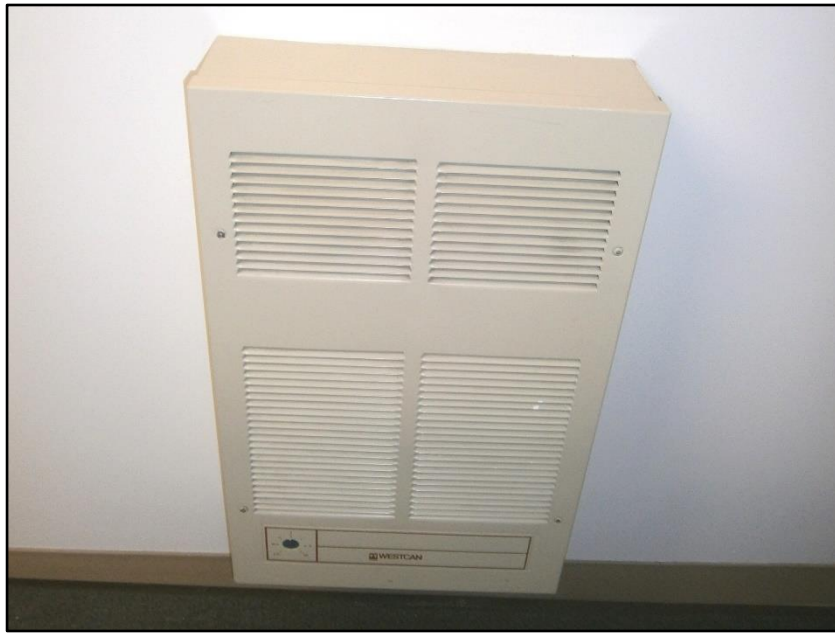
Figure 5.2.5.a Original forced flow heater

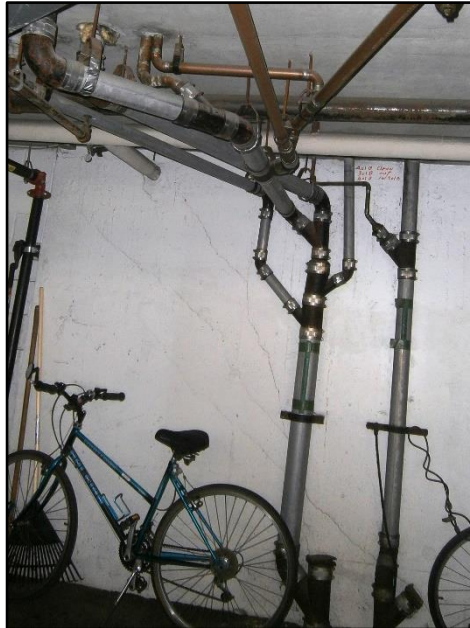
Figure 5.3.3.c Aluminum sanitary pipes in the parking garage

- .D Minor repairs of the sanitary and storm pipes should be performed, as required, using funds from the operating budget
- .E Although costs are not included in this study, as they do not constitute a major repair or replacement, we recommend that camera inspection and flushing of the sanitary pipes and stacks be performed every 5-10 years, using funds from the operating budget
